# Huntington Creek Background Report

Tioga County Soil and Water Conservation District

**APRIL 2019**

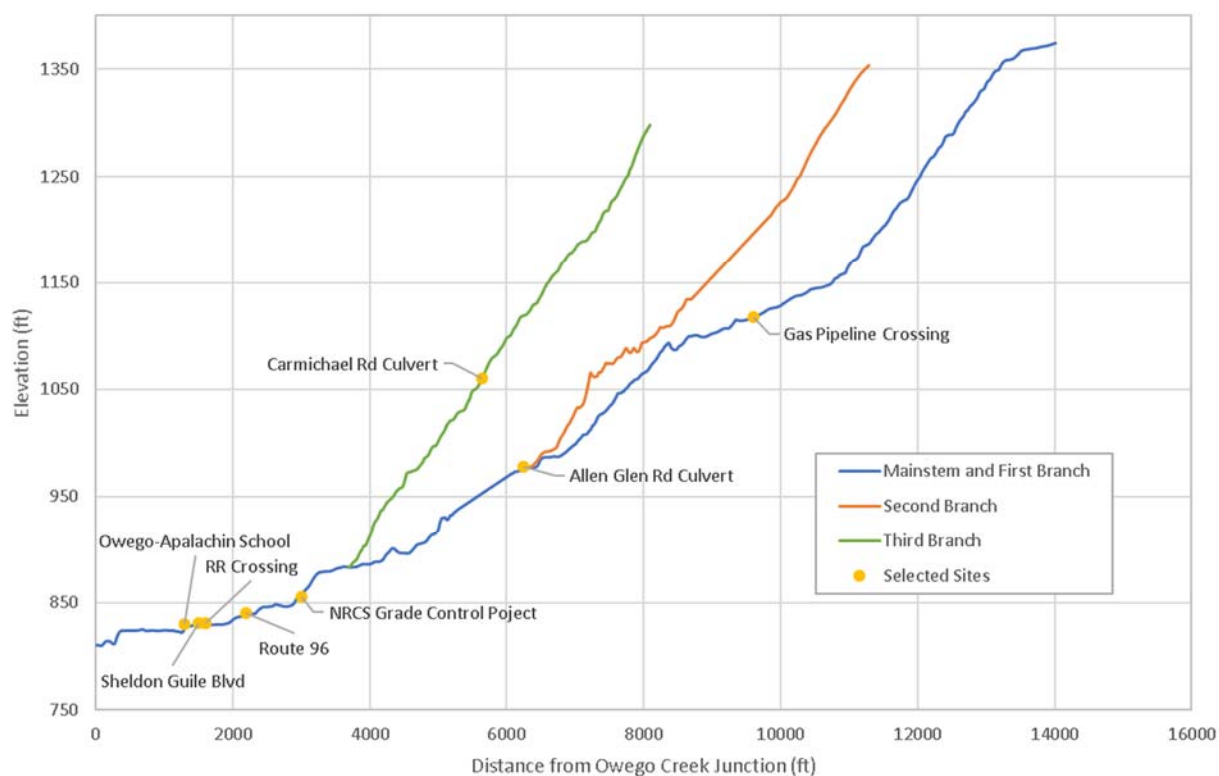
**Figure 3. Longitudinal profile of Huntington Creek, including first, second, and third branches. Several locations discussed in this report are shown along the profiles for reference.**

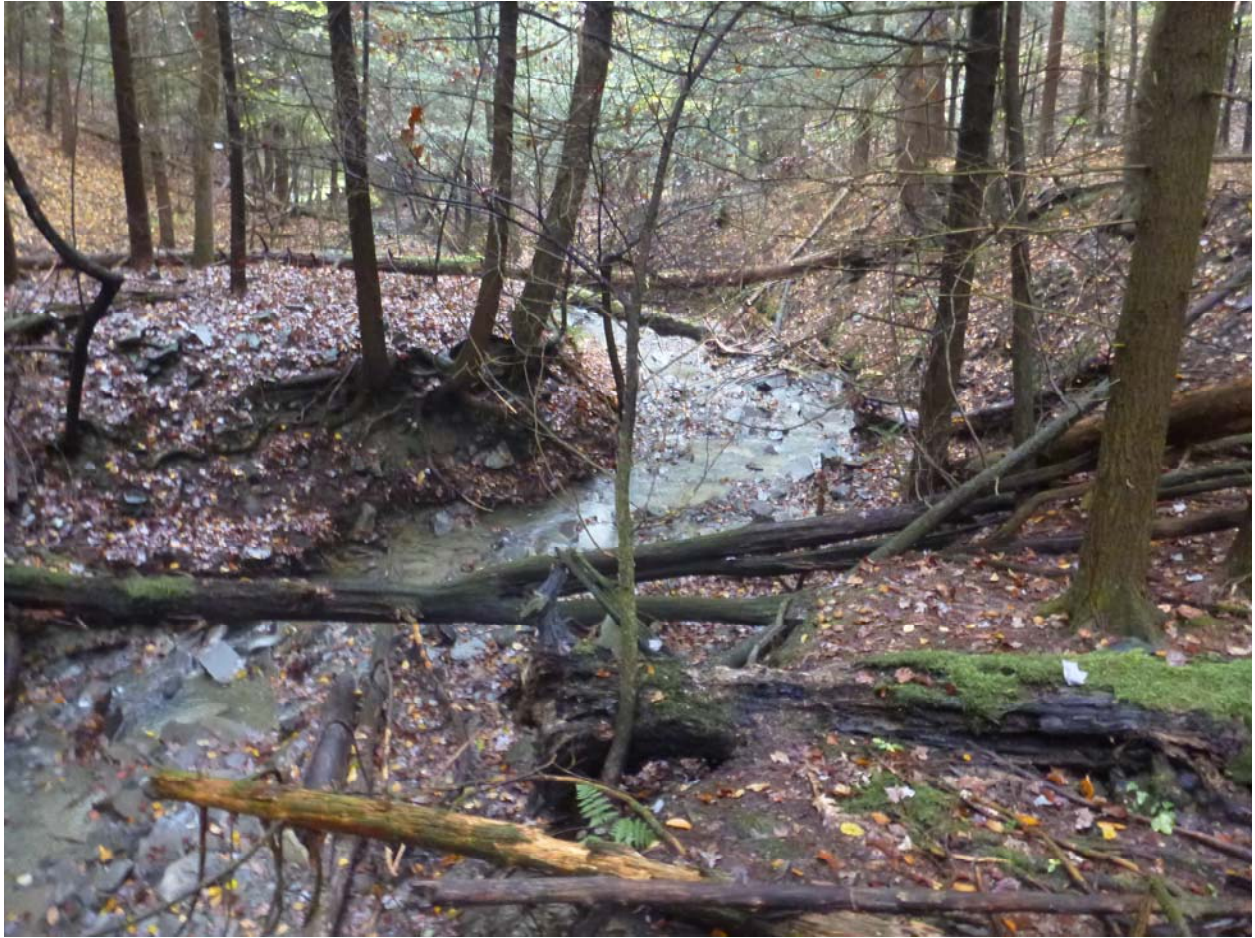
***Figure 6. A representative reach of the second branch. Flow level indicators suggest that bankfull width and depth through this reach are approximately 15 feet and 2 feet, respectively. Slope is approximately 7%. The channel sits well below the floodplain.***

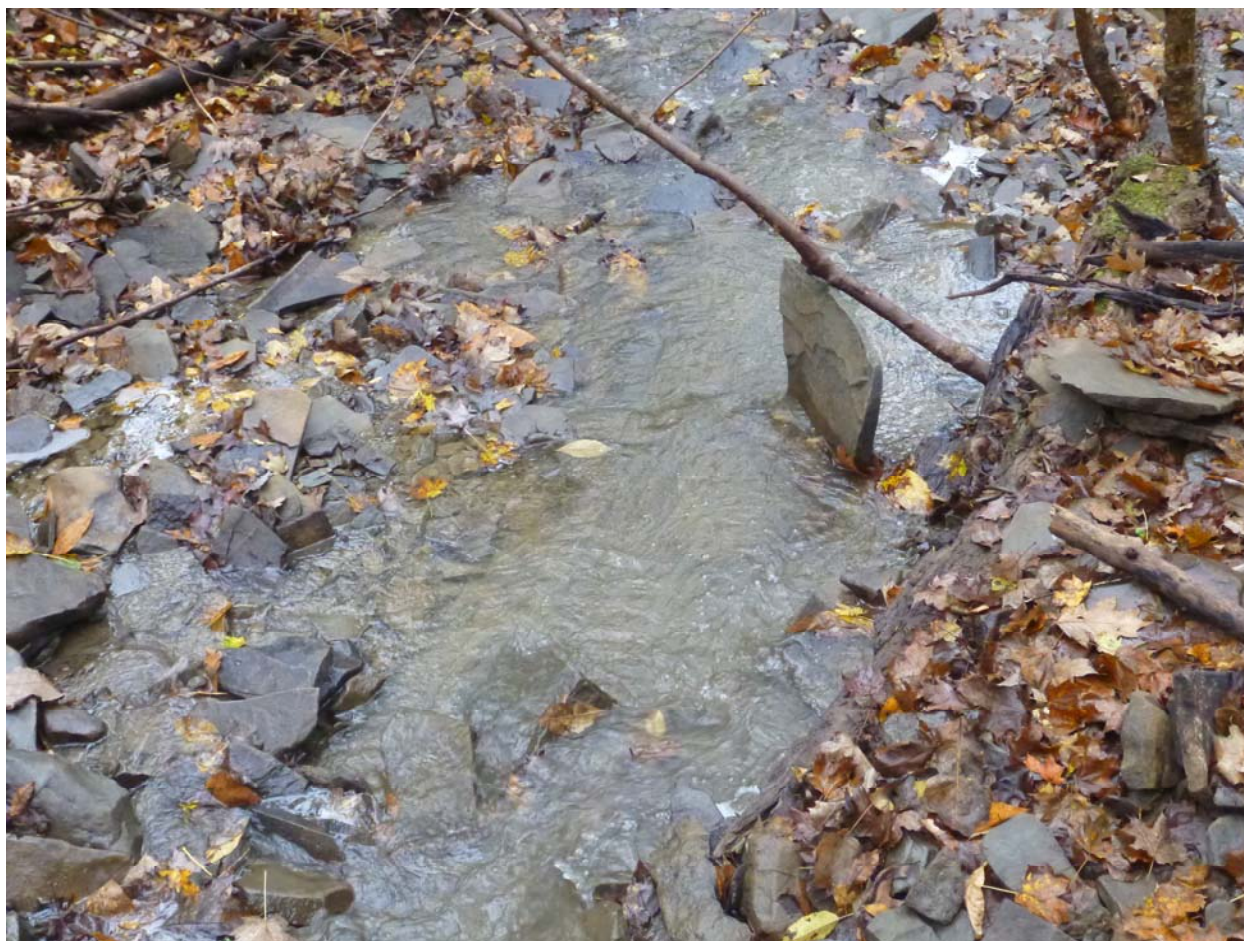
***Figure 7. A clast greater than 1 foot in diameter (intermediate axis) that was recently mobilized in the first branch of Huntington Creek and pinned beneath a small piece of wood. Imbrication of the bed indicates that the bed material is generally mobile.***

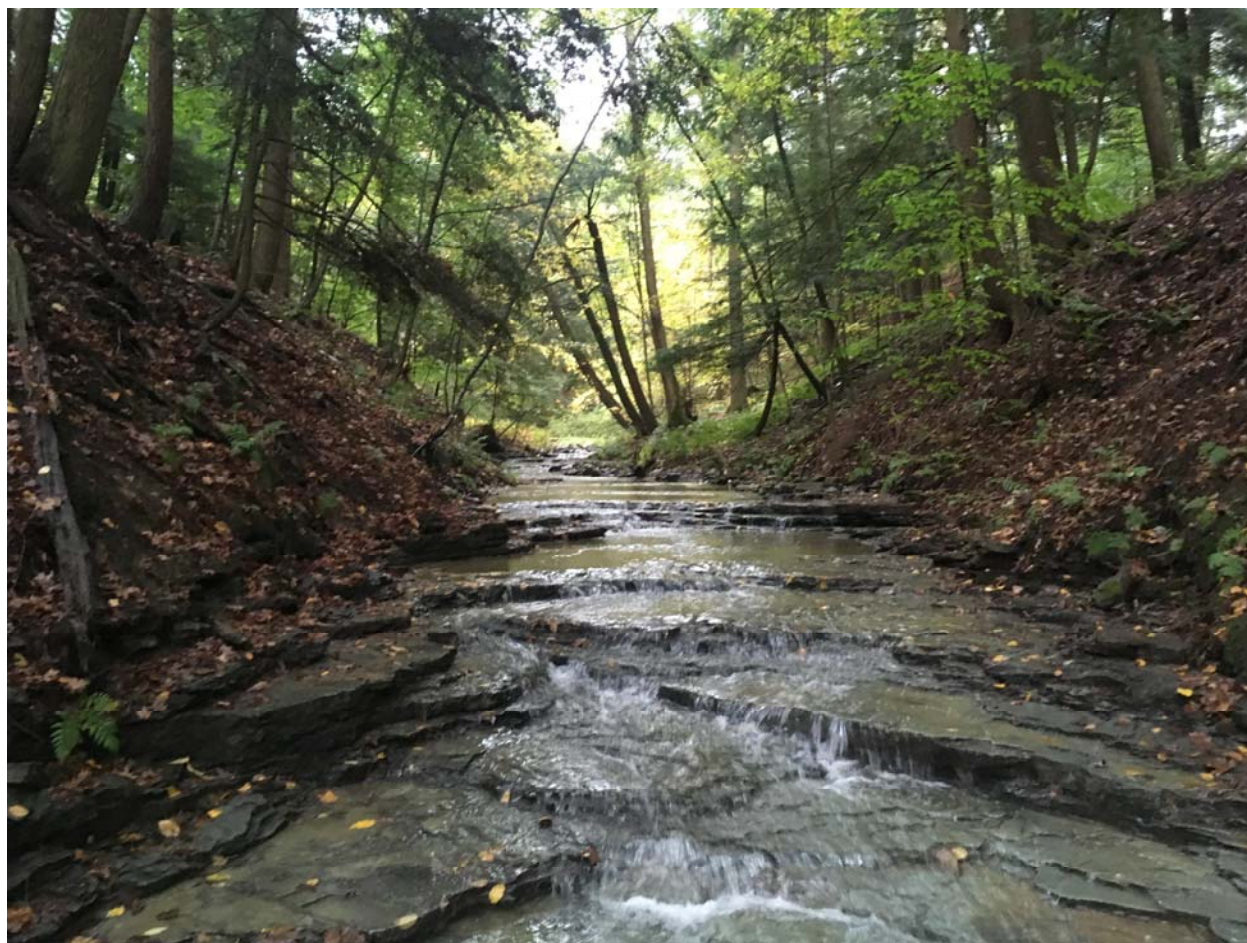
**Figure 8. Looking upstream at a bedrock reach on the upper mainstem of Huntington Creek**

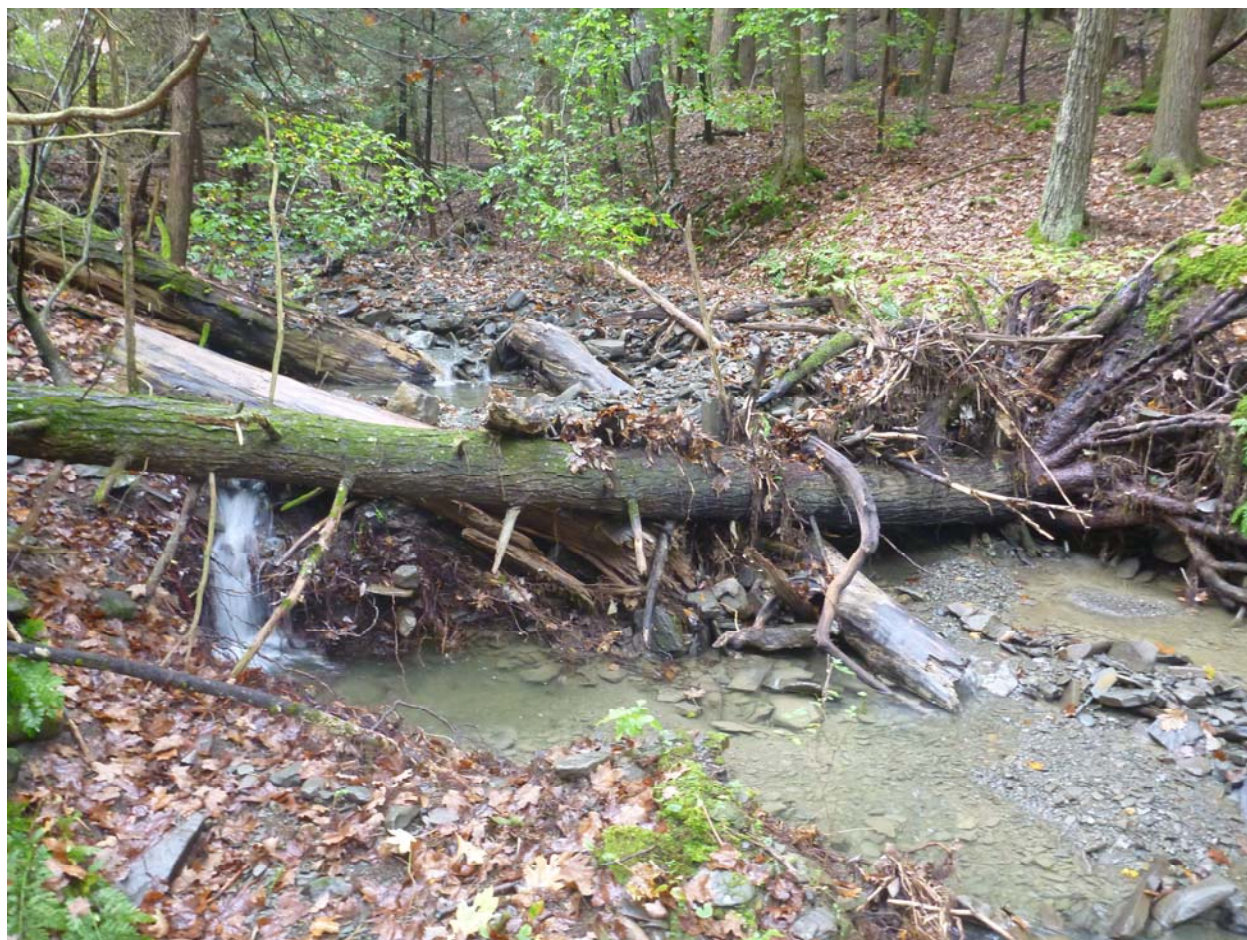
**Figure 9. Rare example of a large woody debris jam in the channel along the second branch tributary to Huntington Creek. In this instance, a single channel-spanning piece of wood initiated a jam by trapping sediment and other woody debris. Approximately 200 cubic yards of sediment are retained as a result of this single structure. The difference in bed elevation across the jam is approximately 2.5 feet.**

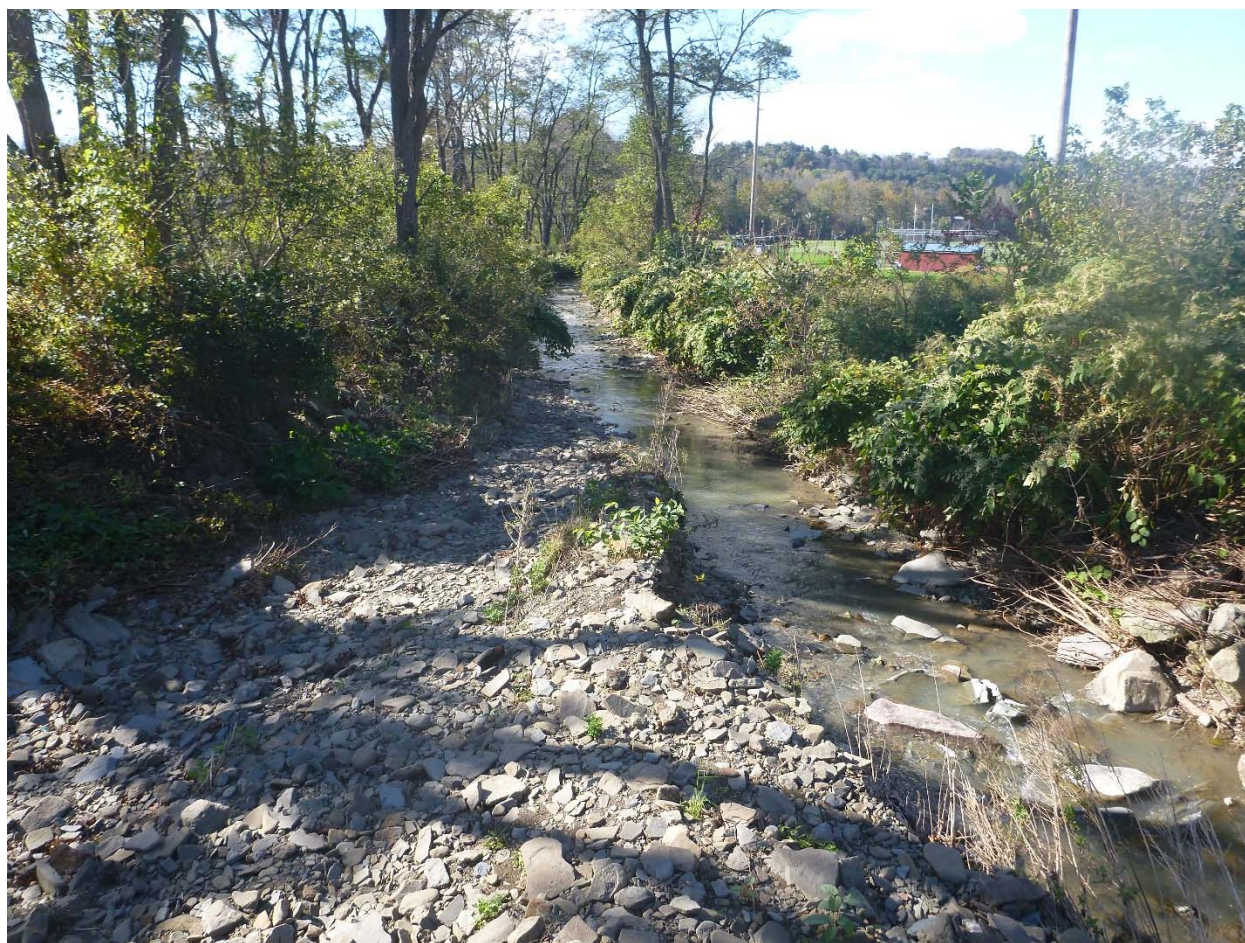
**Figure 10. Looking downstream along mainstem of Huntington Creek as it flows toward Owego Creek across the Owego Creek floodplain (river station 1200). Through this reach, the bankfull width and depth are approximately 40 feet and 2.5 feet, respectively. Slope is approximately 2%.**

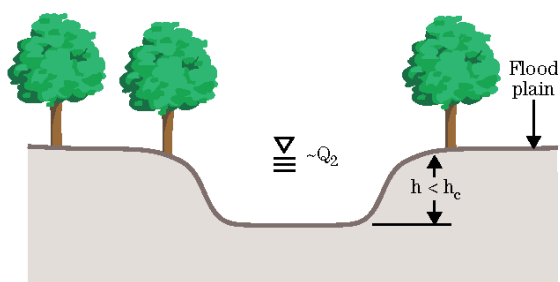
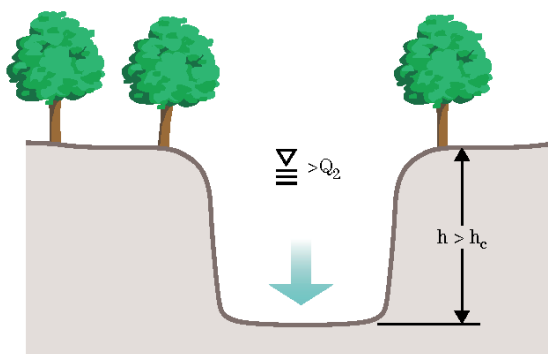
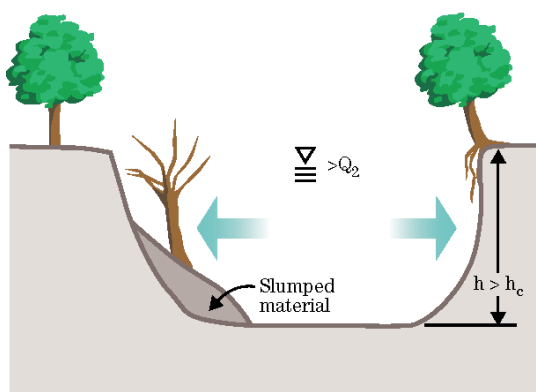
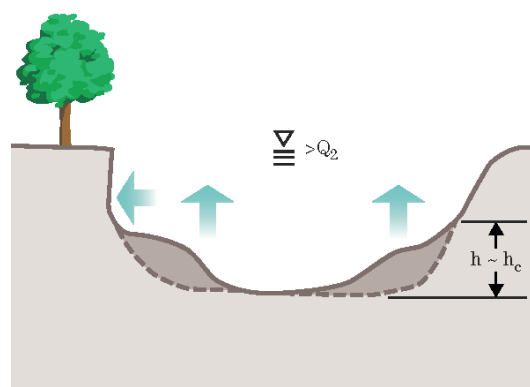
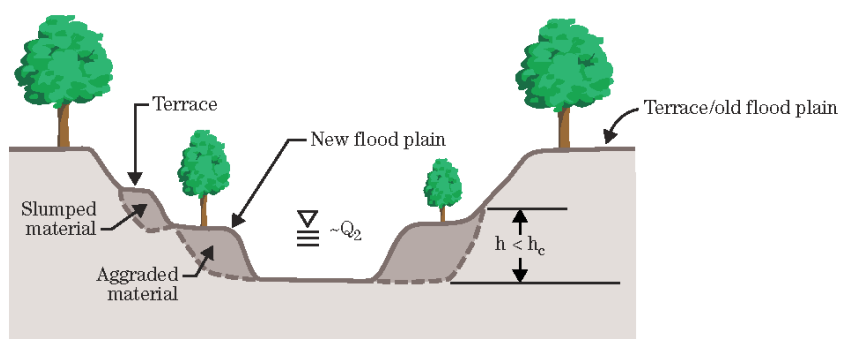
**Figure 11. Conceptual model of incision channel evolution by Schumm et al. (1984). Reprinted from USDA-NRCS (2008).**

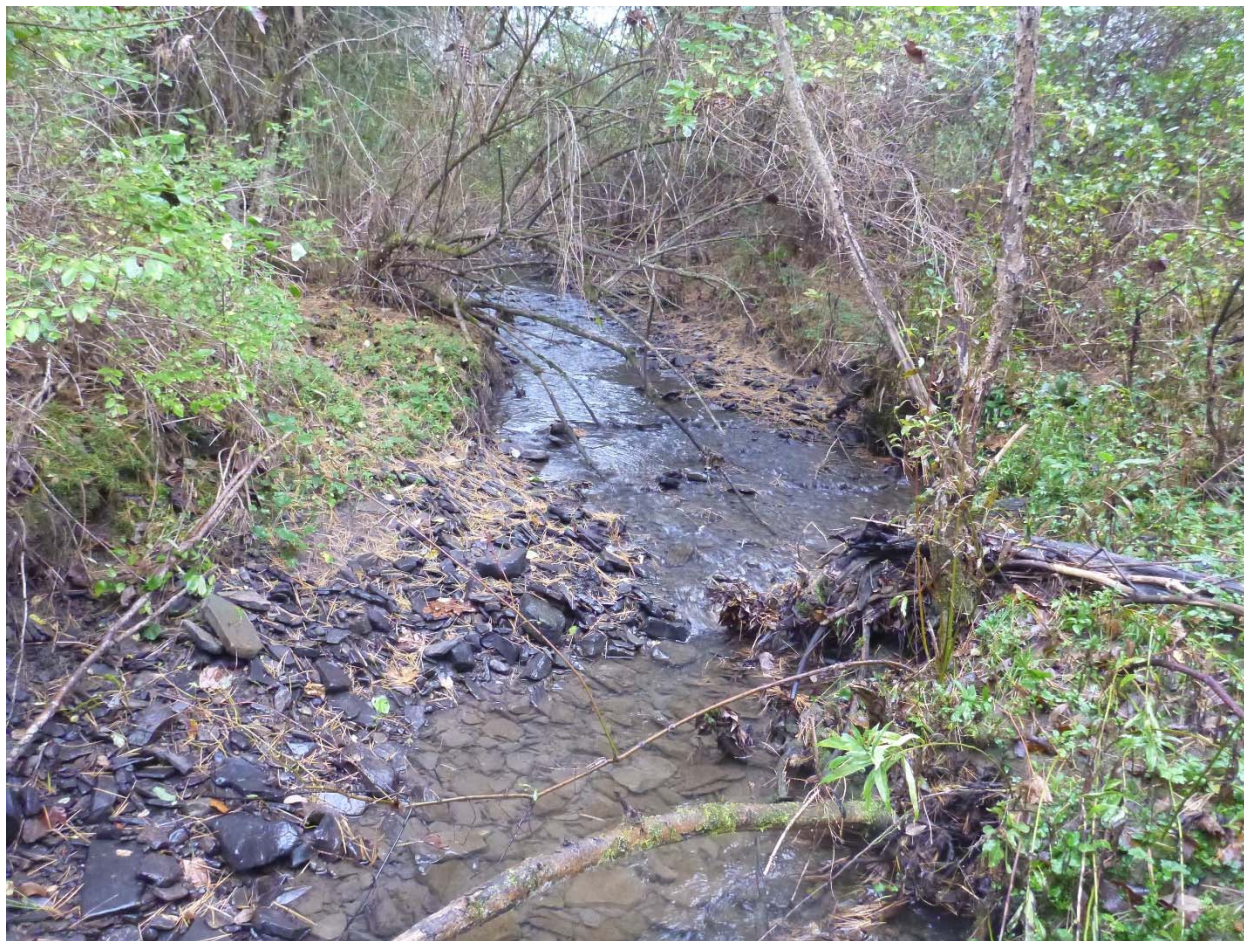
***Figure 14. Small knickpoint at downstream limit of treatment reach Ht-9300***

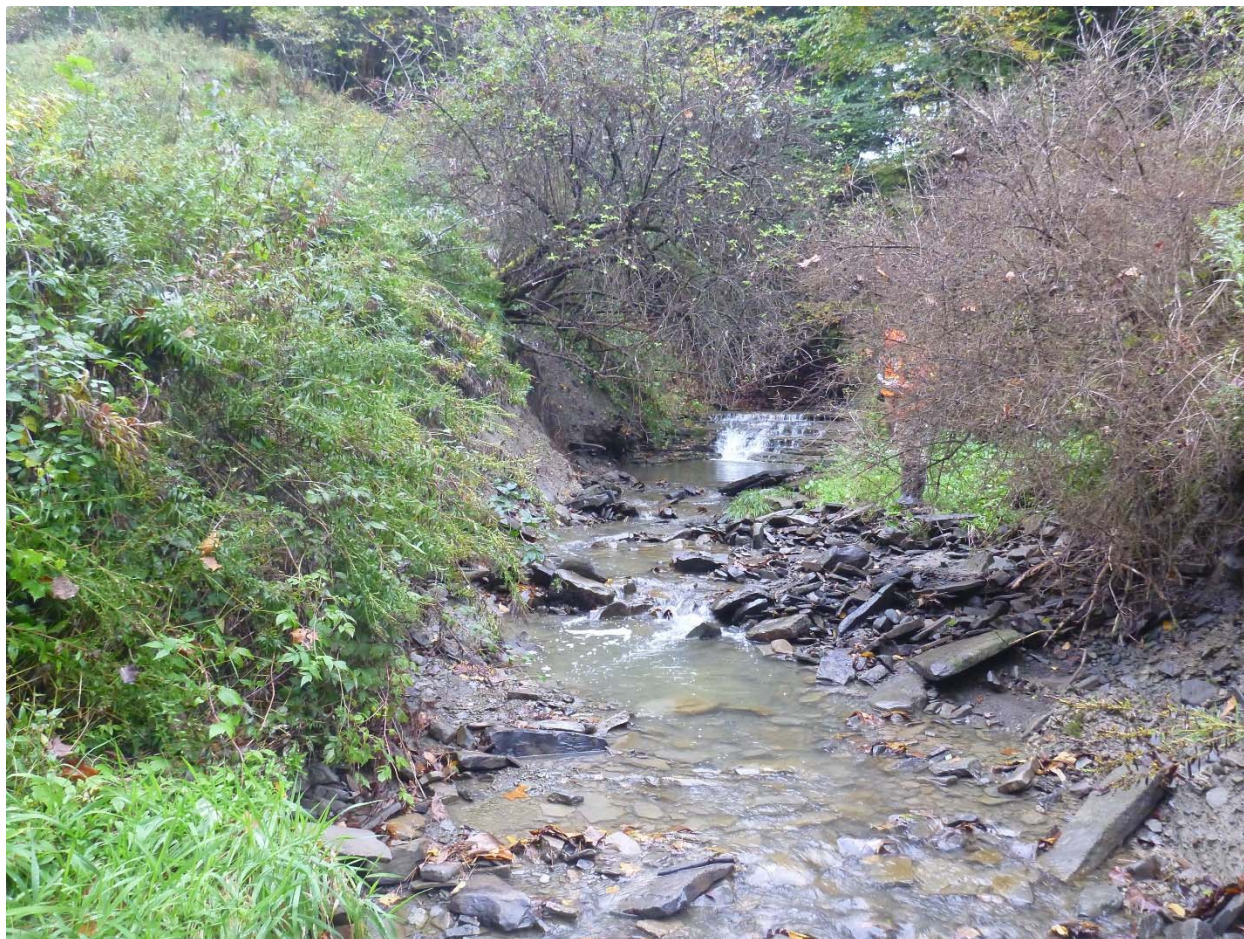
***Figure 15. Looking upstream at bedrock control forming upstream limit of treatment reach Ht-7500. Note open canopy and steep, erodible bank toe on river right (left side of photo).***

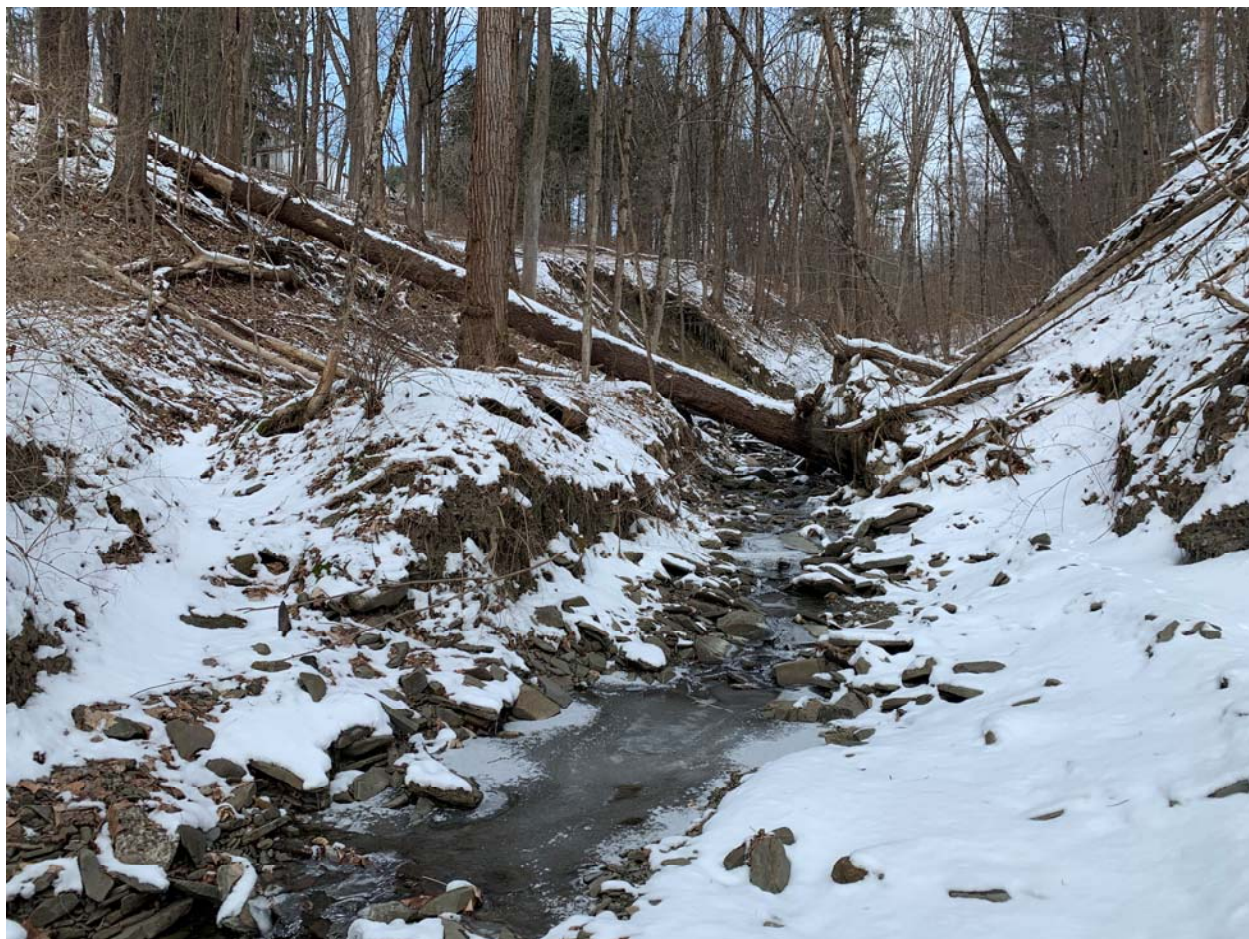
***Figure 33. Looking upstream along the incised third branch near Ht3-100. Photo taken March 6, 2019.***

| Project number | Type | Description | Photo or image reference |
|---|---|---|---|
| Ht3-100 | Grade Control | The third branch between the confluence and Carmichael Road shows evidence of continued downcutting along the channel bed and drainage channels leading from the road. Bedrock is exposed along the bed in numerous locations. Regrade the banks to a more stable angle where possible and install engineered large wood and/or rock to stabilize the bed, raise grade level, and moderate coarse sediment supply. Length of treatment would be up to 1,500 feet. | Figure 33 |

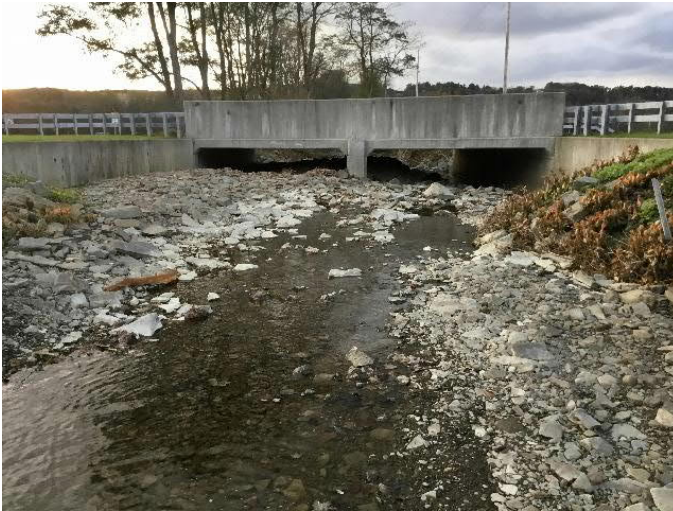
- The structure is severely undersized (estimated capacity is approximately one-tenth of the 10-year peak flow) and clogs frequently during floods.
- Lateral restriction of channel movement by concrete and timber walls along the banks has forced all sediment deposition to occur in the streambed, reducing conveyance capacity.

Inlet of Sheldon Guile Boulevard crossing over Huntington Creek. Note sediment nearly filling culvert structures.

- Replace the school access bridge structure with an appropriately-sized structure to reduce flood risk, improve public safety, and enhance aquatic passage. Consider raising the structure.
- Consider moving the bus garage entrance driveway approximately 500 feet north along Sheldon Guile Boulevard. This would allow construction of a narrower bridge and reduce the impact of flooding to the bus garage entrance. See Figure 3 for illustration of this recommendation.
- Include educational component to crossing replacement and floodplain restoration to involve and inform students and teachers and extend community outreach.

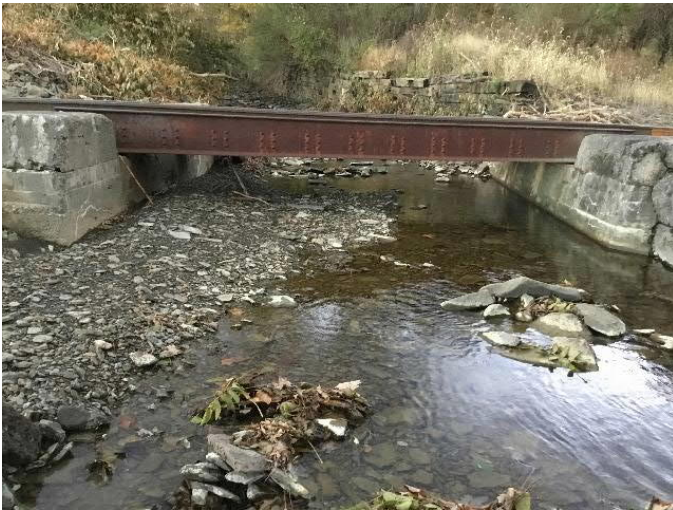
Outlet of Owego & Hartford Railroad bridge over Huntington Creek. Note low bridge clearance, constriction of stream by bridge abutments, and timber retaining wall lining upstream channel.

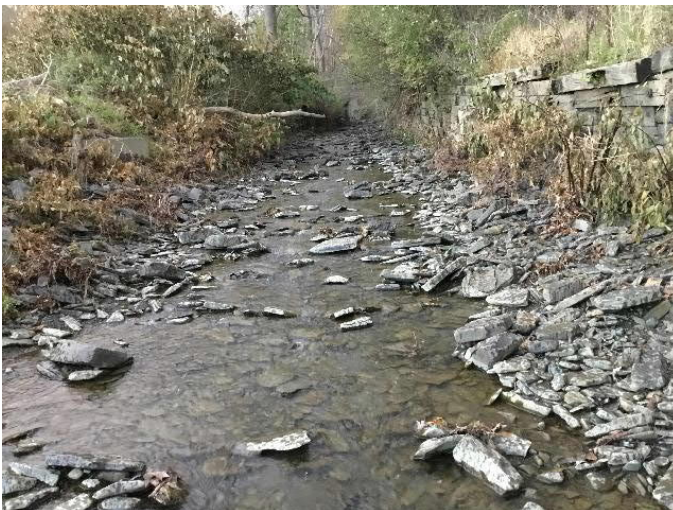
Huntington Creek channel upstream of Owego & Hartford Railroad bridge. Note leaning timber retaining wall lining stream channel on river left (right side of photo).

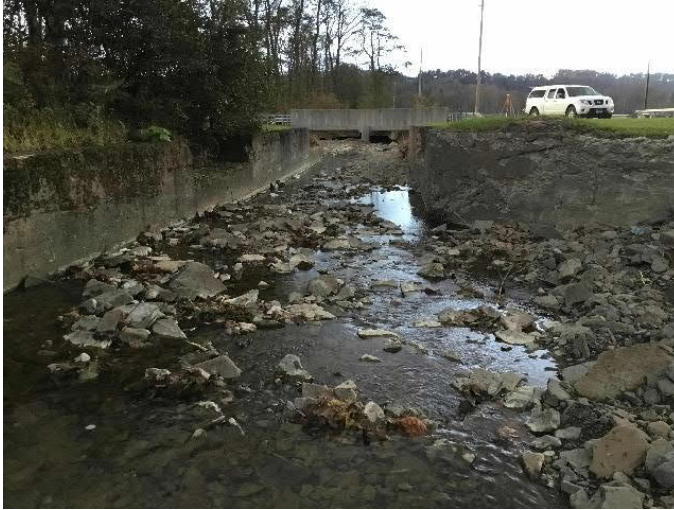
Huntington Creek channel downstream of Owego & Hartford Railroad bridge, looking toward Sheldon Guile Boulevard bridge. Note the concrete retaining walls lining the channelized stream.

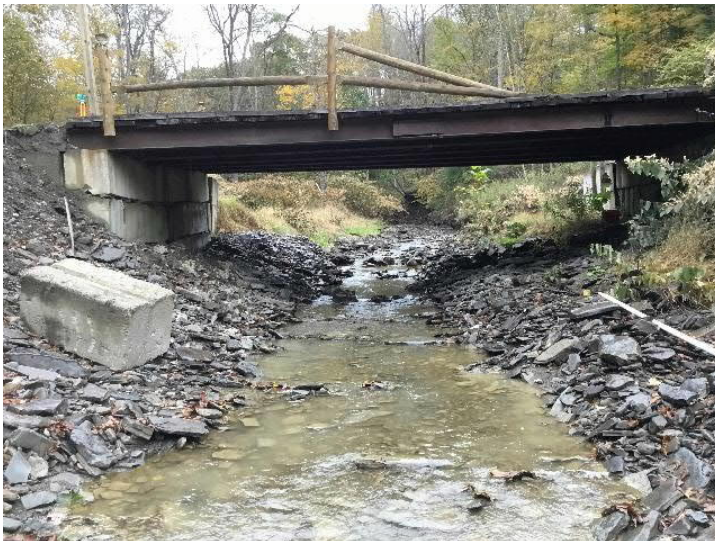
- Abutments and wingwalls are in poor condition (sagging or collapsed).
- A ford crossing is located just upstream of the crossing.
- Some planks in the wooden bridge deck are deteriorated or completely rotten. Planks have been placed over the bridge deck lengthwise to support vehicles.
- Natural sediment deposition may have been modified by channel work using heavy equipment.

Private Driveway off Dean Street over Huntington Creek (downstream). Structure inlet. Note sagging abutment and displaced concrete waste block on left bank.

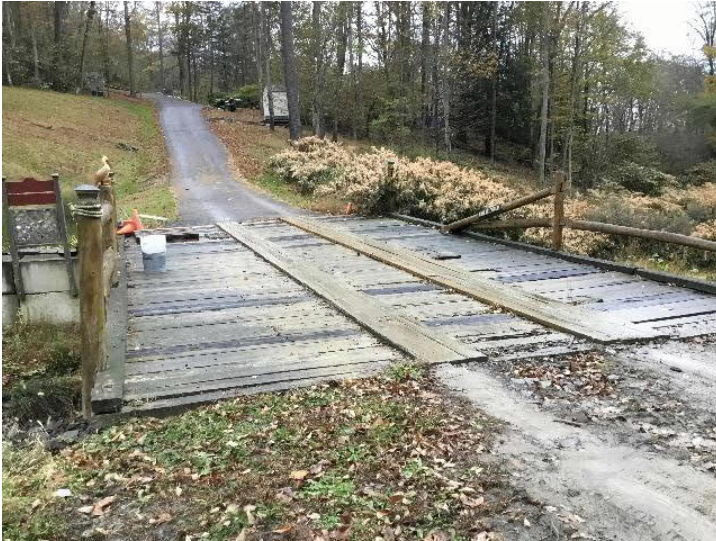
Private Driveway off Dean Street over Huntington Creek (downstream). Photograph of bridge deck. Note planks placed lengthwise on bridge deck to support vehicle traffic.

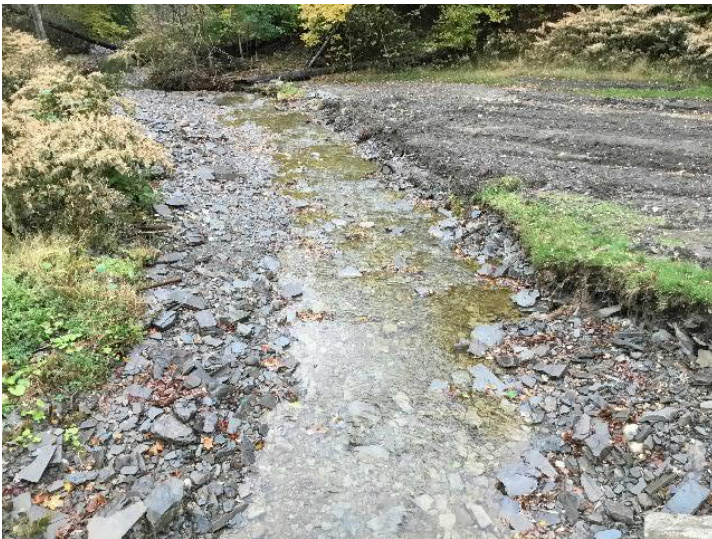
Private Driveway off Dean Street over Huntington Creek (downstream). Area of heavy machinery work in channel downstream of crossing structure.

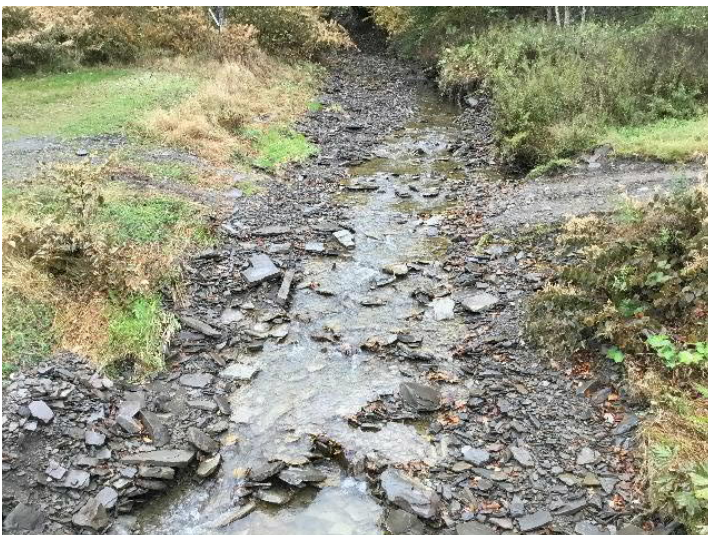
Private Driveway off Dean Street over Huntington Creek (downstream). Ford upstream of crossing structure.

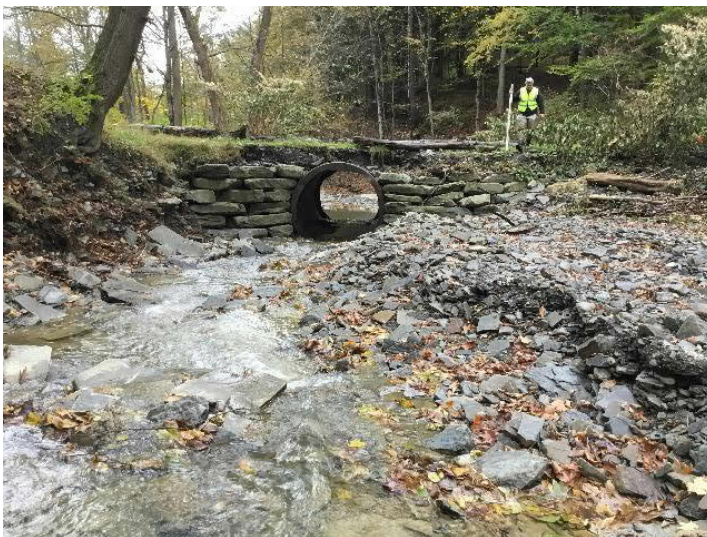
- The crossing structure is constructed from an old, repurposed steel tank and severely constricts flow. The crossing is undersized hydraulically, with an estimated capacity less than the 10-year return interval flood event.
- The homeowner stated that the crossing has overtopped three times in the two months prior to the crossing survey. These events caused serious erosion to banks and road fill. The homeowner also indicated that they have lost at least 3 feet of driveway width on both sides of the crossing. At the time of the crossing survey, they were unable to receive deliveries of heating fuel or firewood due to the crossing's poor structural condition.
- At the crossing outlet, the road embankment slope is nearly vertical or overhanging and very unstable.
- Sediment deposition was observed in the upstream and downstream channel.

Private Driveway off Dean Street over Huntington Creek (upstream). Structure inlet. Note erosion of road along top of structure, and sediment deposition on river right.

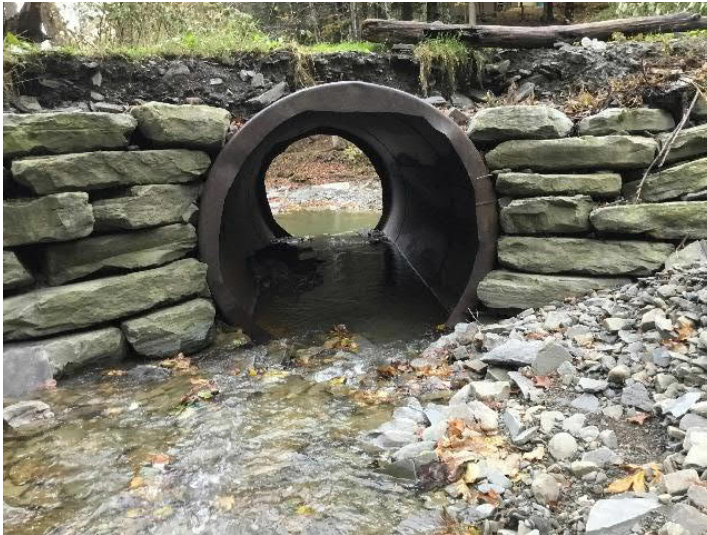
Private Driveway off Dean Street over Huntington Creek (upstream). Close-up photograph of structure inlet. Note inadequate fill/cover material above culvert, erosion of road along top of structure, and sediment deposition on river right.

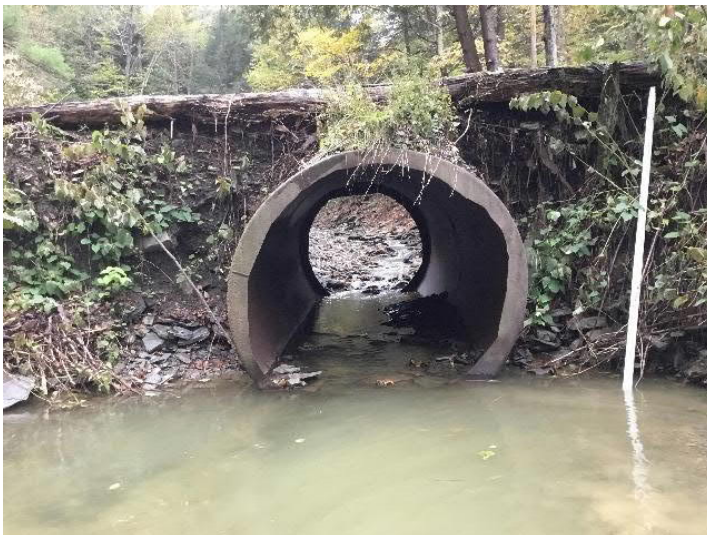
Private Driveway off Dean Street over Huntington Creek (upstream). Crossing structure outlet. Note erosion of road embankment on either side of structure.

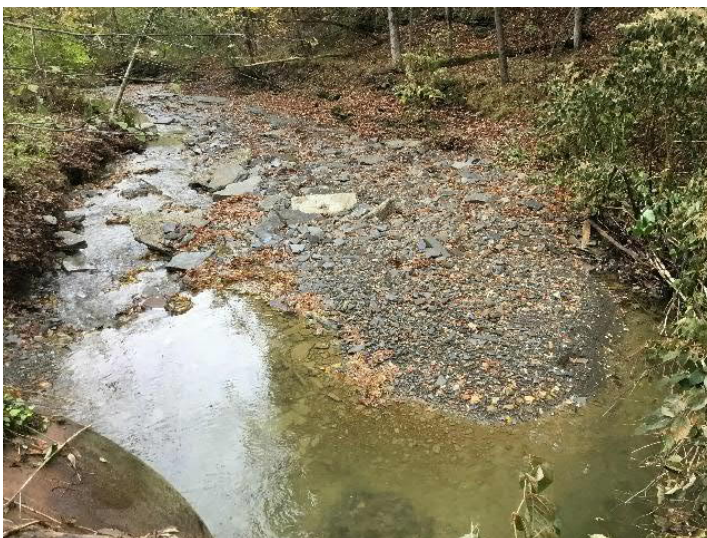
Private Driveway off Dean Street over Huntington Creek (upstream). Streambank erosion on river left and deposition on river right, downstream of crossing structure.

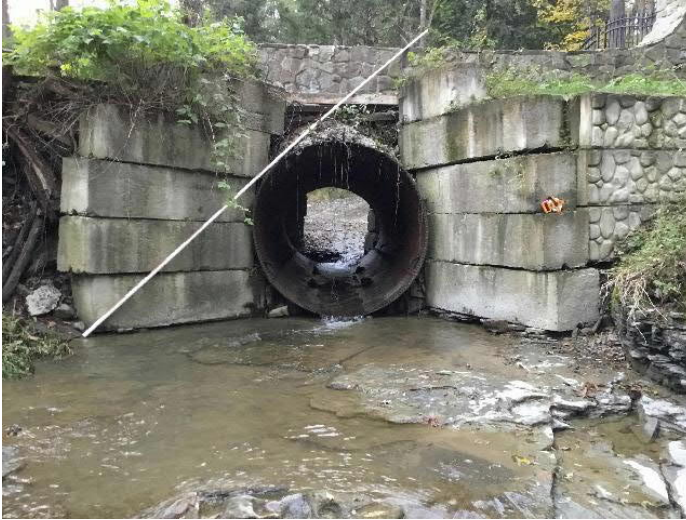
Private (Winery) Driveway off Allen Glen Road over Huntington Creek. Structure outlet. Note debris and plywood in place of headwall and severely misaligned wingwalls.

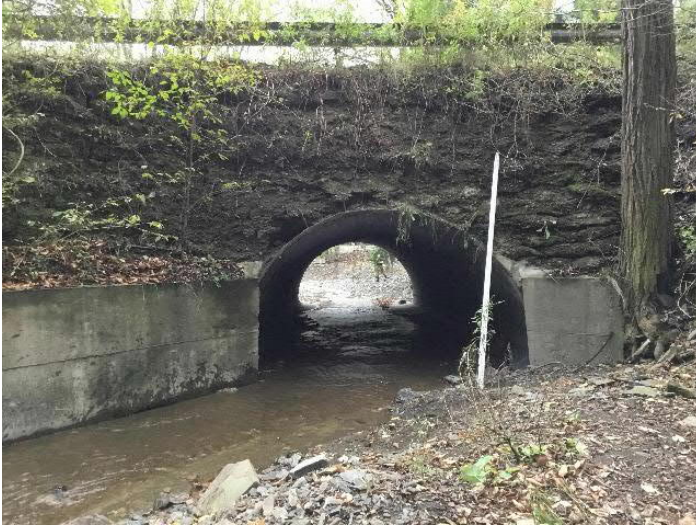
- The structure is adequately sized to convey the 100-year return interval peak flow but serves as a constriction given its width relative to bankfull width.
- The perched outlet limits/prohibits aquatic passage.
- The wingwalls are in critical condition (near collapse).
- The upstream headwall is completely gone. The road appears to be supported by stacked bags of grout that were installed behind the missing headwalls when it was installed.
- Material has eroded from the road embankment, threatening the roadway integrity.
- The streambed consists of a concrete-lined channel for approximately 130 feet, extending upstream, through, and downstream of the structure.

Allen Glen Road over Huntington Creek.  
Structure inlet. Note missing headwall  
exposing embankment formed of stacked  
bags of grout.

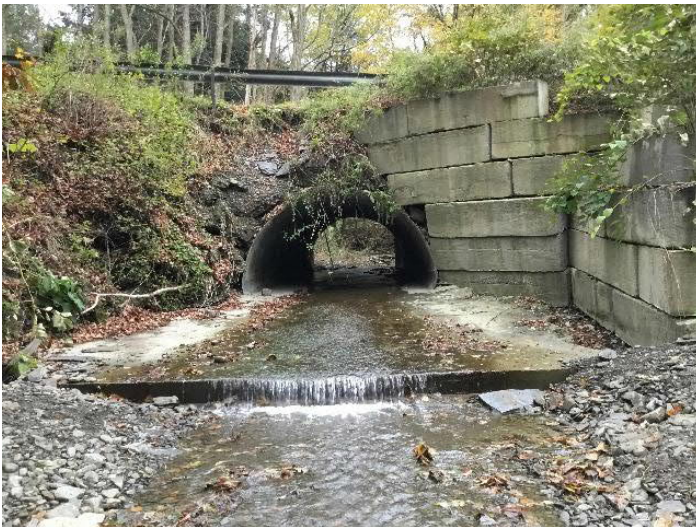
Allen Glen Road over Huntington Creek.  
Structure outlet. Note unstable wingwall  
and concrete-lined streambed, eroding  
road embankment, and outlet drop.

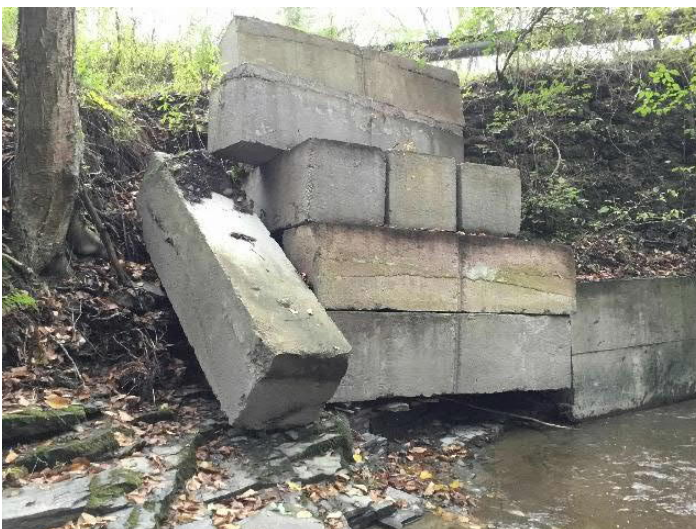
Allen Glen Road over Huntington Creek.  
Severely unstable wingwall upstream of  
structure inlet.

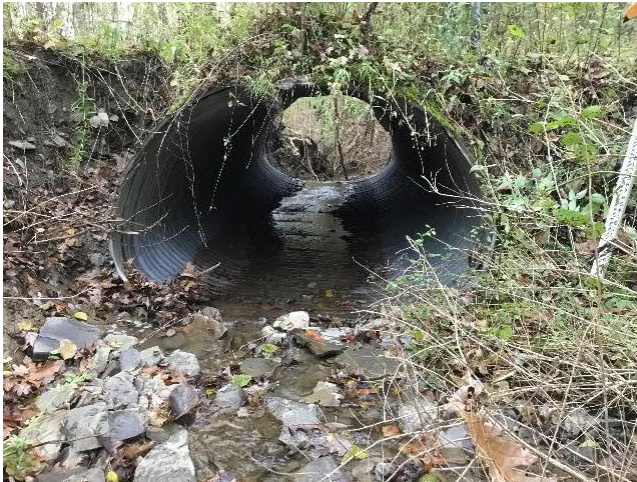
- The structure is adequately sized to convey the 100-year peak flow but is narrower than bankfull width and constricts streamflow.
- The perched outlet limits/prohibits aquatic passage.
- The stream is incised; channel erosion is a significant source of sediment to the stream.

Private Driveway/Access Road off Carmichael Road over Tributary to Huntington Creek. Structure inlet. Note erosion on left side of structure.
